# Manhole Inspection Summary

Manhole # S31WW1006MH

**Location** Address: **101 UPNOR RD**

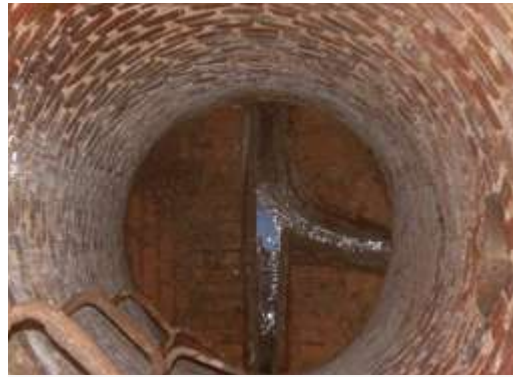
Top View

Corroded steps. Bench debris.

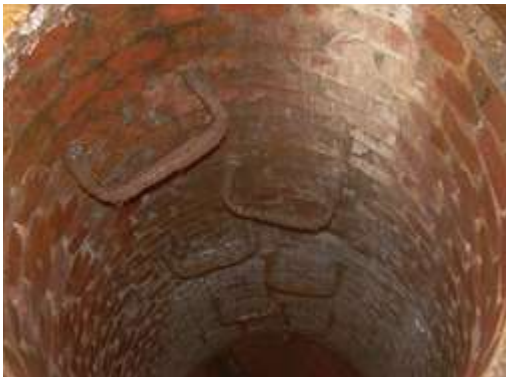
Defect

Frame leaks. Adjustment infiltration.

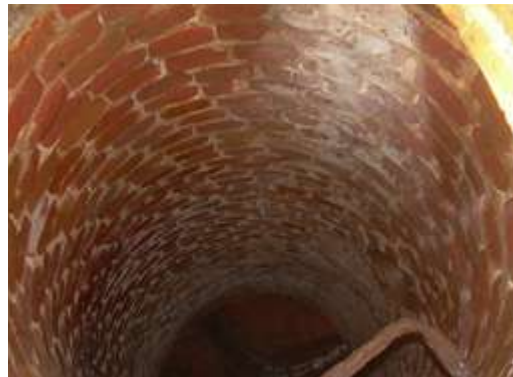
Defect

Adjustment and Barrel infiltration.

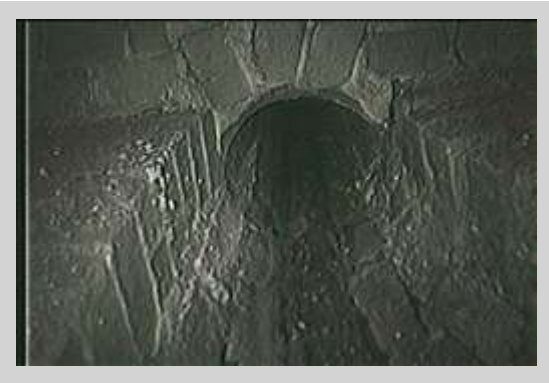
### 8 in. Circular Gravity Sewer Pipe Out @ 12 O'Clock

Infiltration: **Evidence** Pipe Seal Cond: **Cracked**

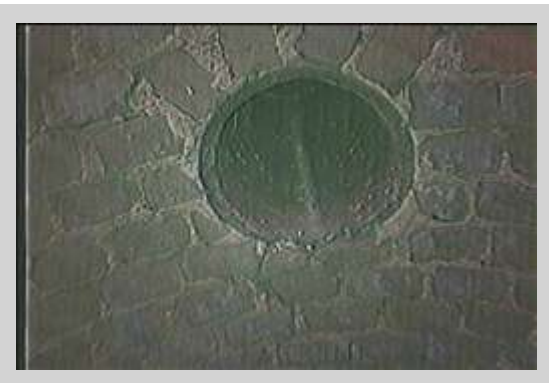
### 8 in. Circular Gravity Sewer Pipe In @ 3 O'Clock

Infiltration: **Evidence** Pipe Seal Cond: **Cracked**

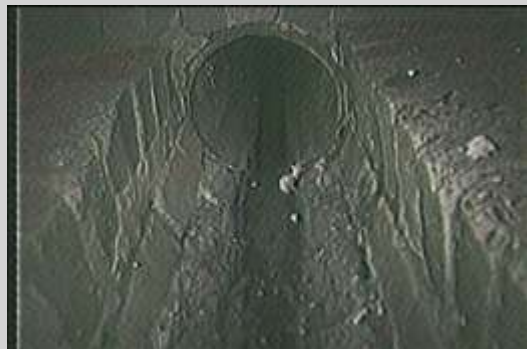
Pipe In @ 6 O'Clock

Channel deterioration.

Infiltration: **Evidence**

Pipe Seal Cond: **Cracked**
